**Subject: Annual Inspection Report
Addison Municipal Airport**

ANNUAL INSPECTION REPORT

ADDISON MUNICIPAL AIRPORT

ADDISON, ALABAMA

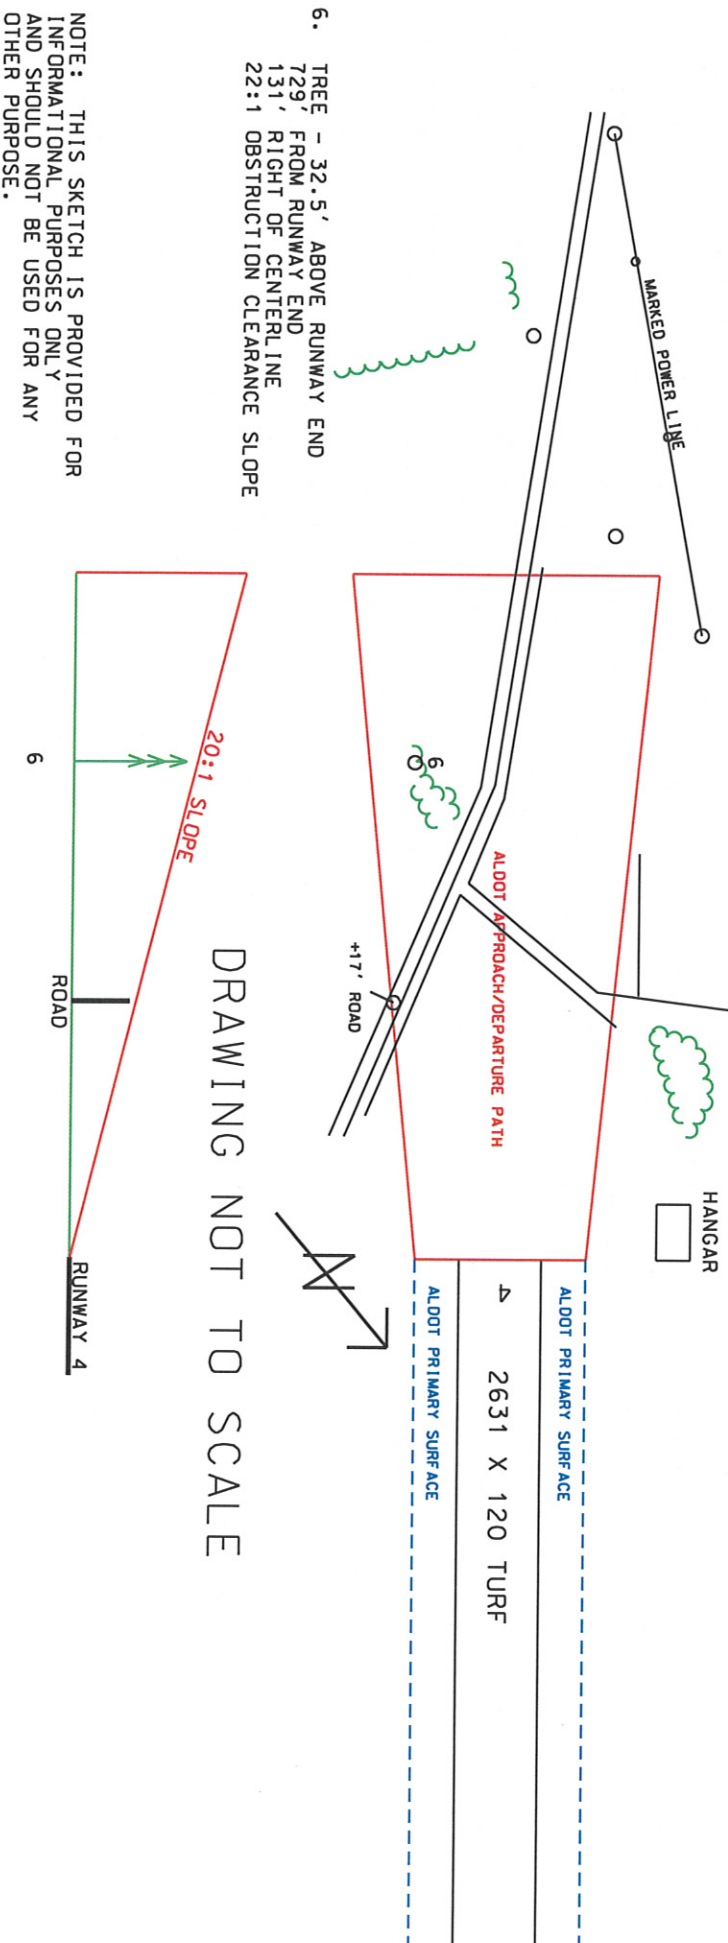
REQUIREMENTS FOR STATE AIRPORT LICENSE RUNWAY 4

- Runway 22: Trees identified as Tree # 1, Tree # 2, and Tree # 3 violate the ALDOT 20:1 Approach Departure Path (See Photo # 1 and Appendix 2).
- Runway 4: No obstructions, but Tree # 6 could become a hazard if allowed to continue to grow into the Approach/Departure Path (See Photo # 2 and Appendix 3).

Inspection Area	Violation/Maintenance	Corrective Action
Approach/Departure Path	Violation	Remove obstructions
Primary Surface	Violation	Remove vegetation
